**Gully Erosion in Anambra State, South East Nigeria: Issues and Solution**

Obiadi. I.I, Nwosu.C.M., Ajaegwu.N.E, Anakwuba.E.K, Onuigbo.N.E, Akpunonu.E.O,  
Ezim.O.E.

Geological Sciences Department, Nnamdi Azikiwe University, Awka, Nigeria.  
izuchukwuig@yahoo.com

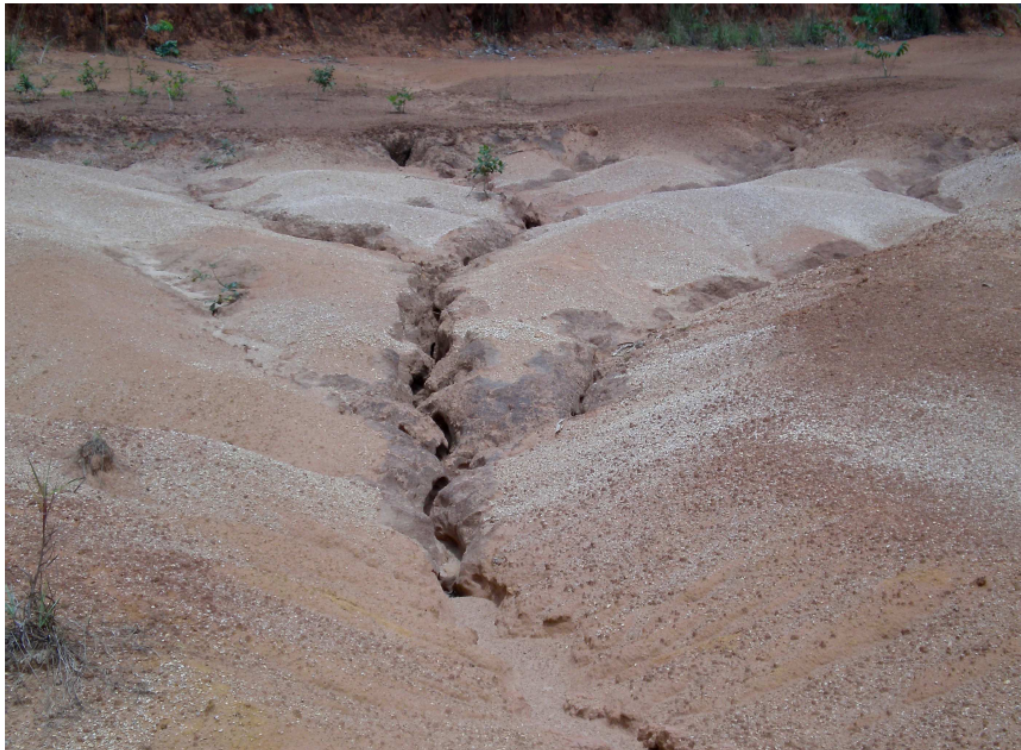
**Figure 5:** Onset of gully erosion triggered by deforestation and topsoil excavation.

The hydrogeochemical characteristics of the area are also important factors in the development and growth of gullies by way of chemical weathering (Egboka et. al. 1983). The surface and groundwater are slightly acidic, thereby facilitating the decomposition of the cements binding the rock particles together and making them vulnerable to erosion by mass wasting and excess runoff (Egboka and Okpoko, 1984). This same acidic water attack and disintegrate dams and other civil engineering works put in place to control the hazard. Human interference with the natural geologic system has also compounded issues. Most of the erosion sites are around small towns and villages that are well populated. Available lands are put to use for farming and construction works, most of which are without proper design. This leads to blockage/change in the natural water channel ways, concentration of excess runoff with high velocity and eroding potential. Deforestation, a common practice in Anambra State, exposes the soils and rocks to severe gulling (figure 5)

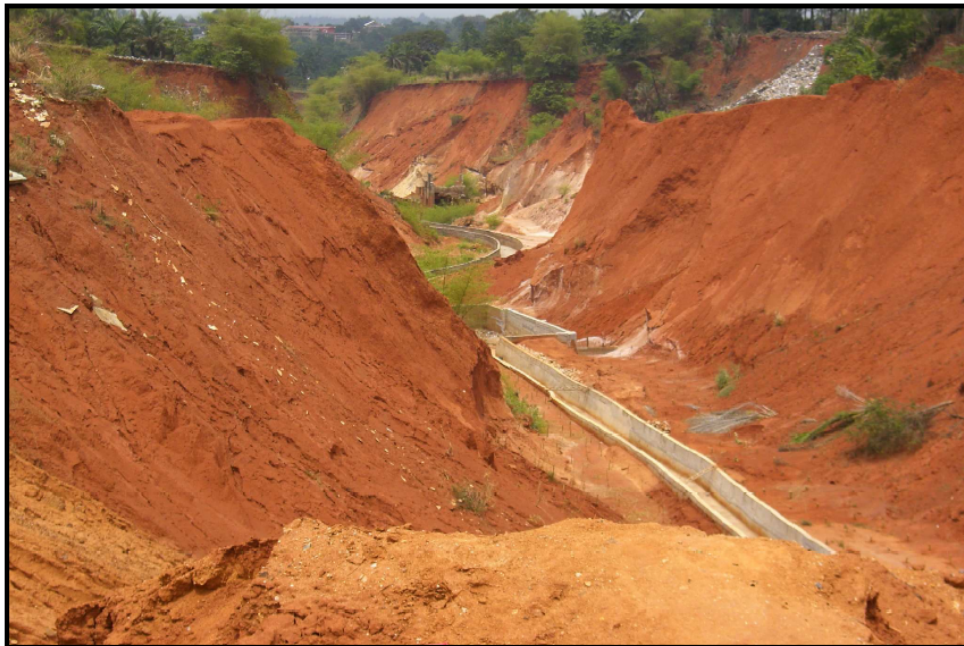
**Figure 6:** Control measure put in place to check gully erosion.

Gulling has persisted despite efforts by the federal government, state governing, local government, towns/community unions as well as individuals. In towns like Nanka, Nkpologwu, Agulu-Ezechukwu, Ekwulobia and Agulu, the gully extends for kilometers with width and depth in tens and hundreds of meter (table 1). Generally most of the gully sites investigated are still very active despite the control measures already in place. In Ekwulobia for example, the mass of rock, pavement, culvert and Bamboo trees used for the control of the gully was observed right at the base of the gully channel obviously dislodged by sliding. Massive civil construction works to contain the menace is on-going at the site and other sites visited (figure 6).

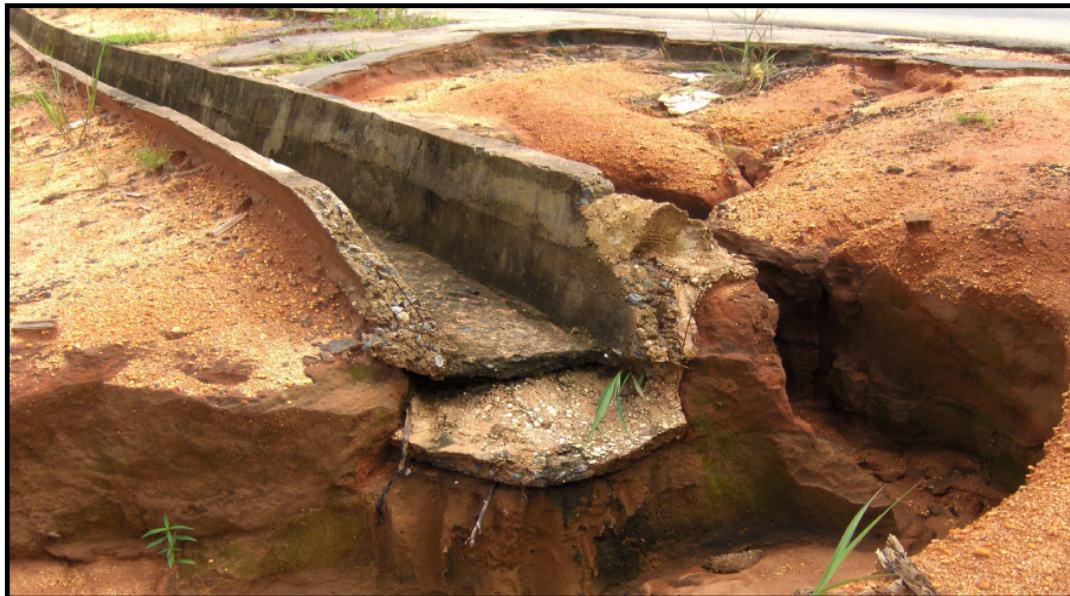
**Figure 7:** Improper termination of drainage channel forming gully erosion triggers.
